## **APPENDIX D**

### **Technical Scope of Work**

#### **Area of Investigation 1 - USOR Property**

#### **Remedial Investigation/Feasibility Study**

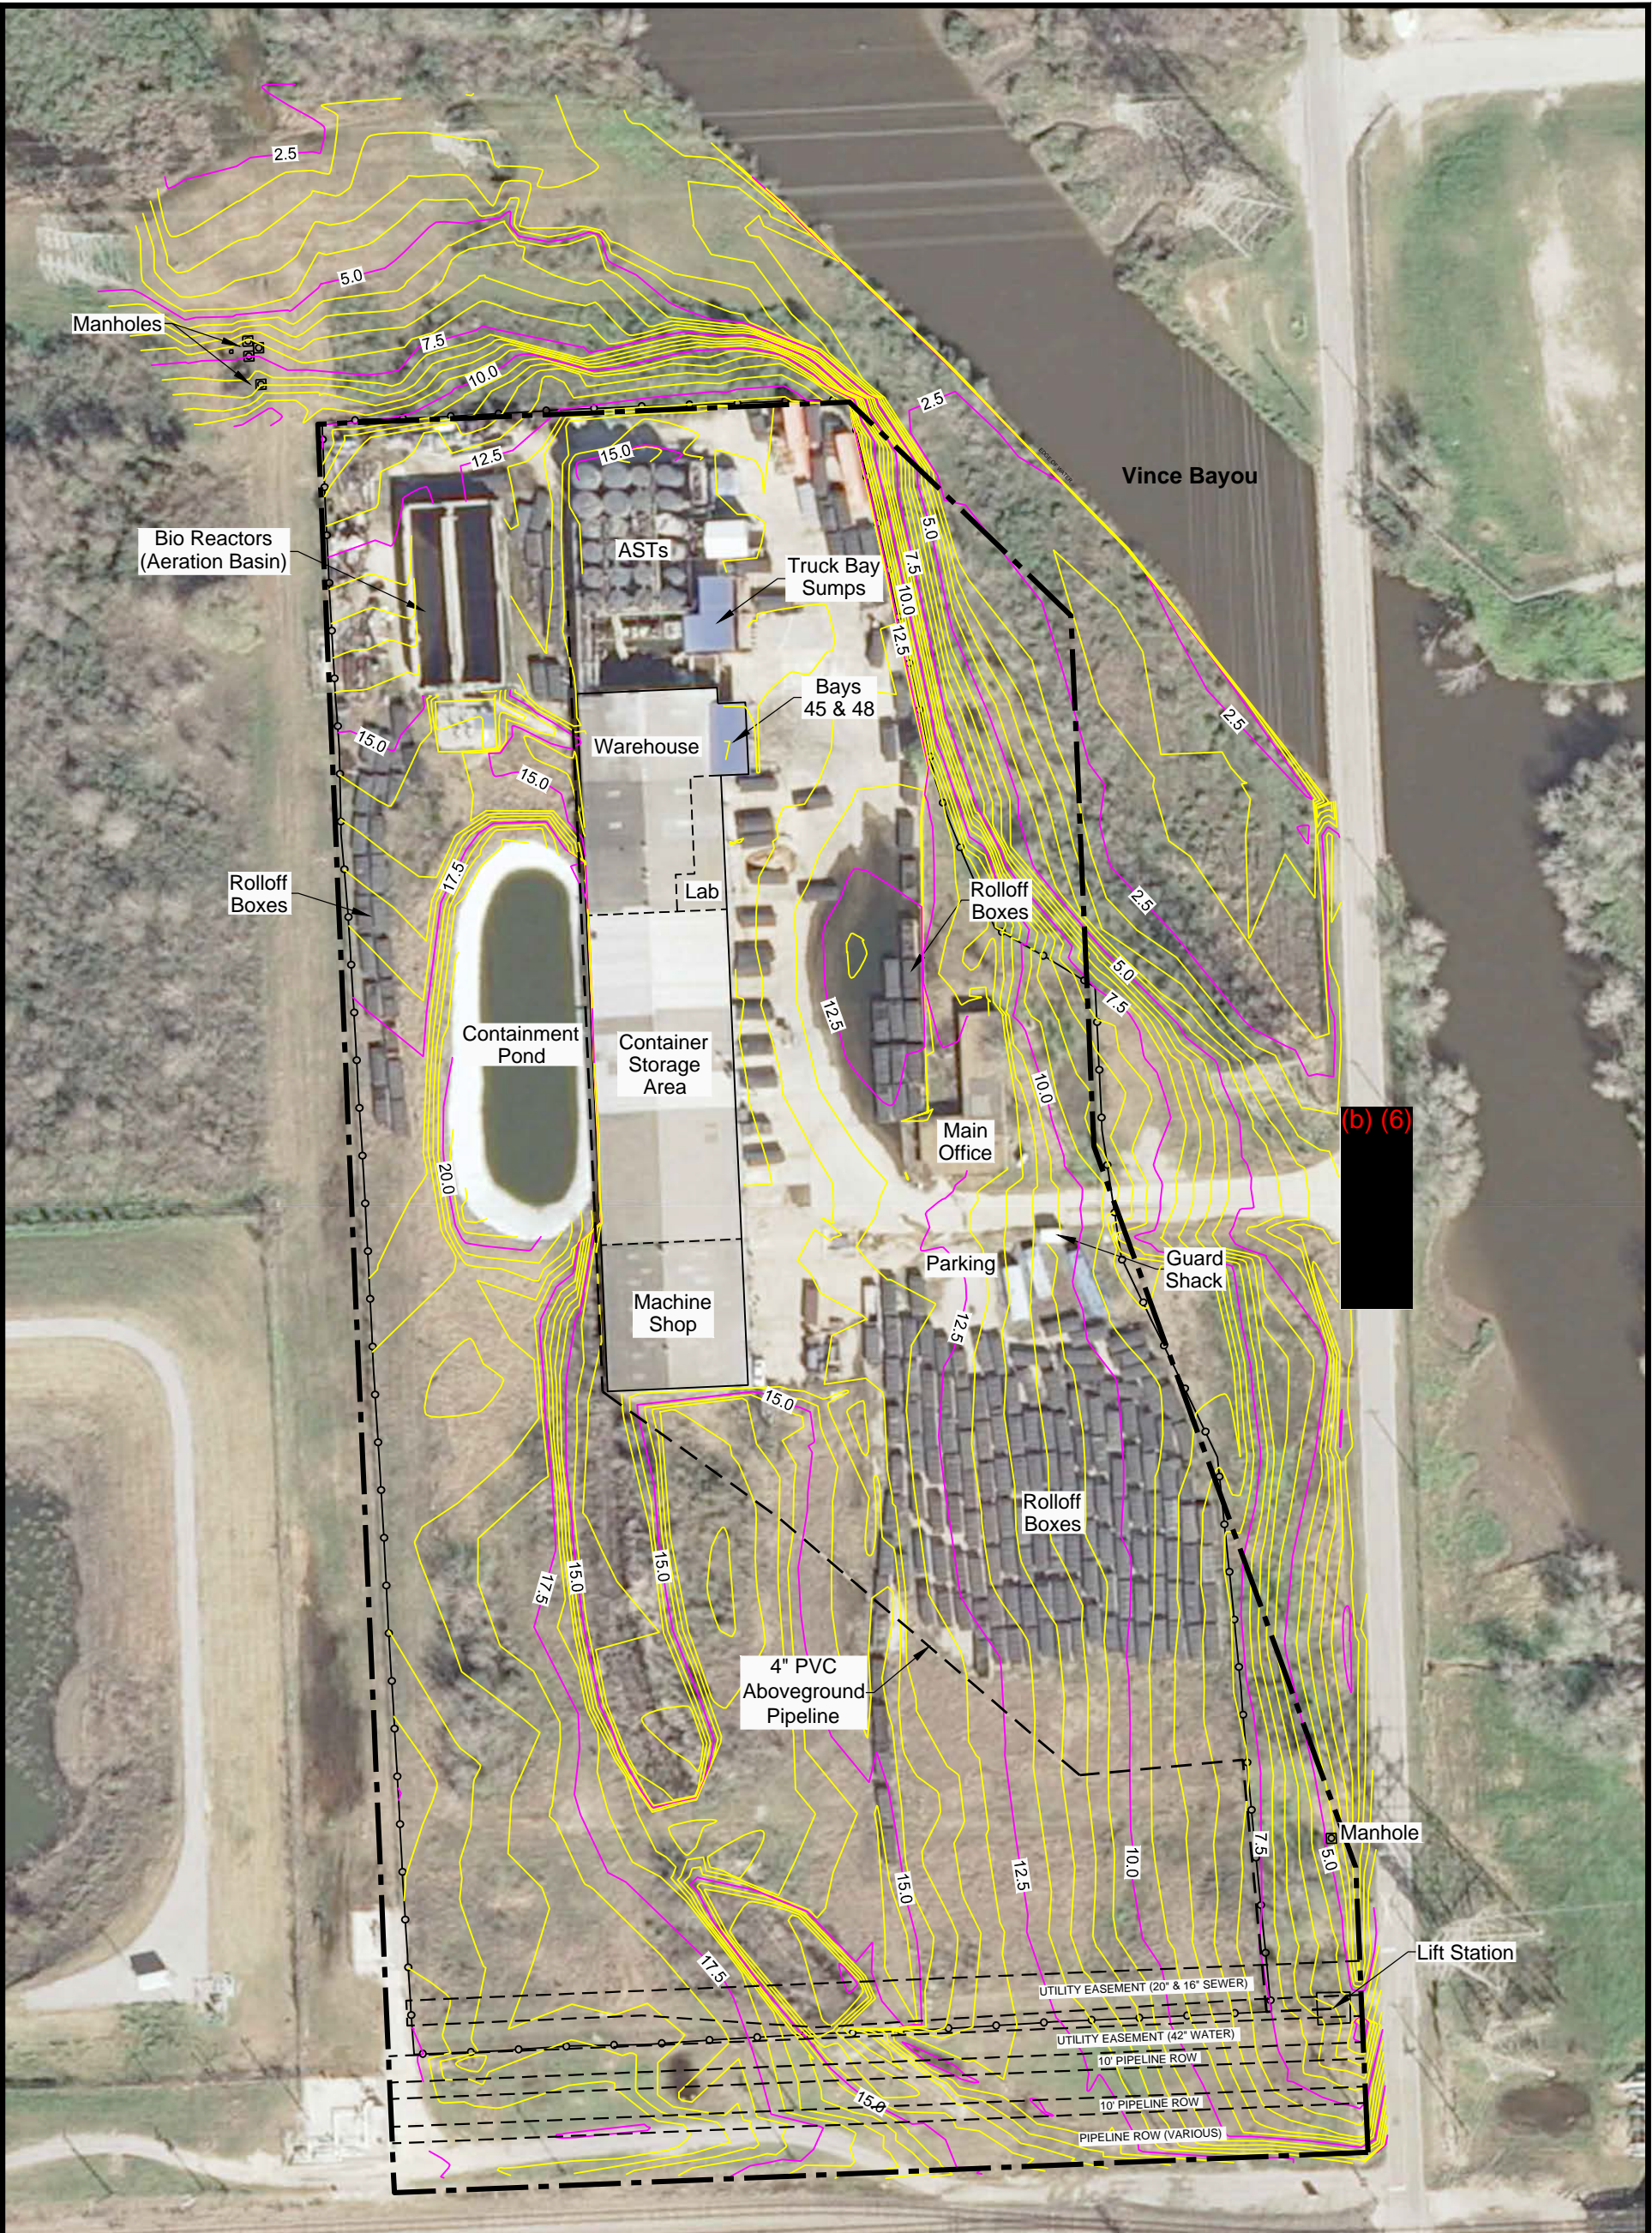
The USOR Property is located at 400 North Richey Street in Pasadena, Harris County, Texas, 77506 (Figure 3). The approximately 12.2 acre property was most recently used as a used oil processing and waste treatment facility by US Oil Recovery LLP. US Oil Recovery LLP began operations on the property in approximately June 2003 and acquired the property in December 2003. Prior to 2004, multiple businesses operated on the property including chemical manufacturing companies (specializing in fertilizers and/or herbicides/pesticides), a cow hide exporter, leather tanner, and companies with unknown operations including storage of various hard goods. Attachment D-1 contains a more detailed listing of the operational history of the property.
